Understanding can help contractors avoid common problems

# Issues in Post-Tensioned Construction

By Bryan Allred

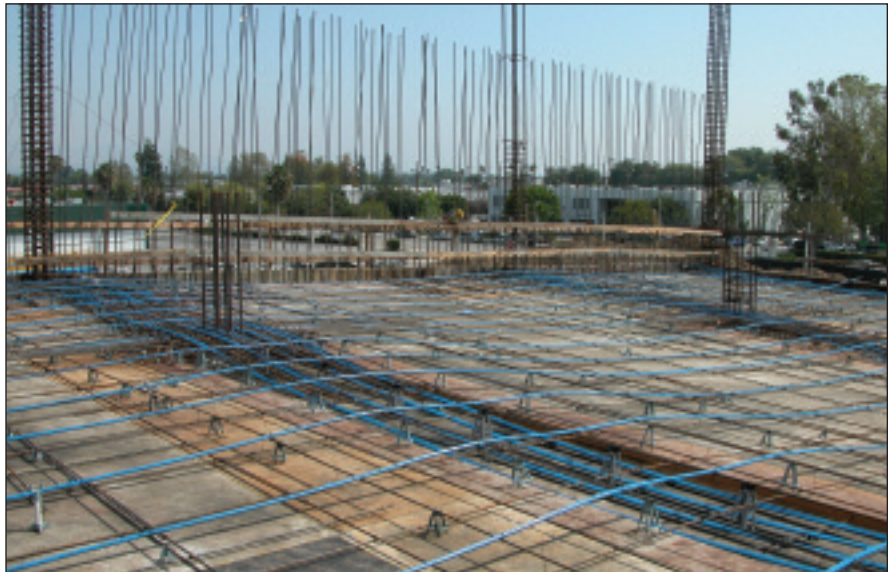
**Top: Post-tensioning tendons are draped within the slab cross section. Bottom: Significant over-balancing of the weight of the concrete with post-tensioning can actually lift and crack the slab.**

One of the main differences between a post-tensioned beam or slab and a typical reinforced concrete element is that the strands drape or profile inside the concrete—their vertical location changes along the length of the member. The tendon profile, which is typically in a concave shape, will try to straighten itself out when stressed. This creates an uplift load (also called a *balance load*) on the concrete that minimizes and often effectively removes the dead weight of the concrete from the stress and deflection calculations.

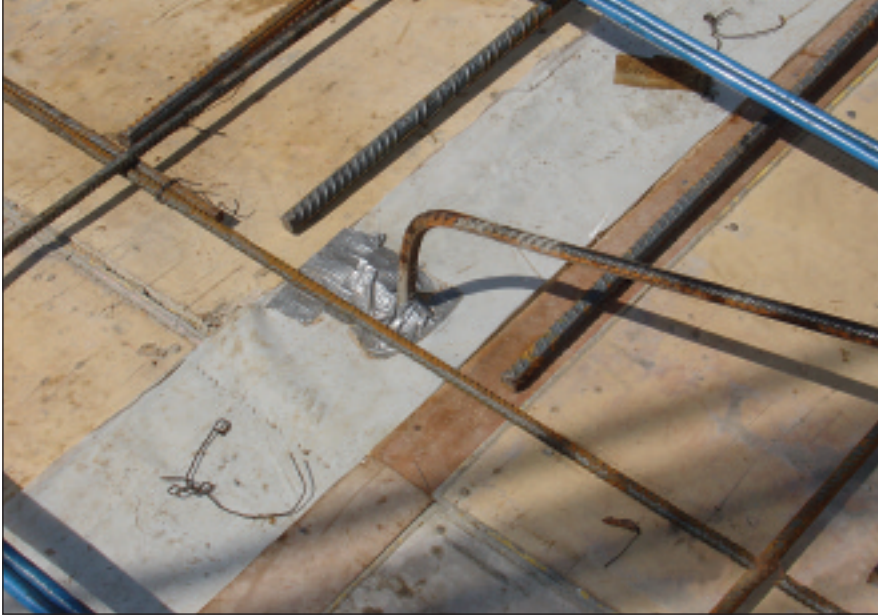
**Top: To prevent restraint, plastic is placed along the top of a wall that the slab is crossing. Bottom: The black foam rubber around the first few inches of the dowels coming out of the adjacent wall will allow the post-tensioned slab to shorten during tensioning without cracking the slab.**

Typical slip details use felt, building paper, or plastic to eliminate the bond of the slab to the walls. Many restraint cracks have been created by engineers or contractors who underestimated the strength of the bond between a slab and concrete or masonry walls. When rebar is required between the slab and wall, pipe insulation or foam rubber surrounding a portion of the dowel can be used to allow relative movement without activating the dowel.

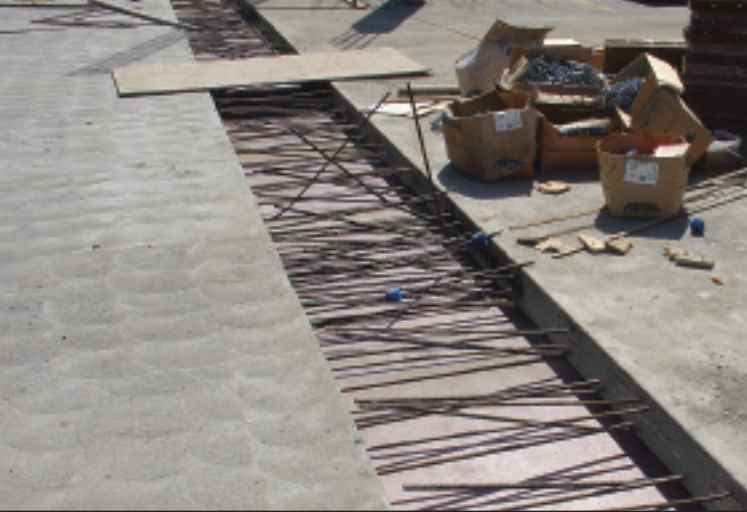
**Reinforcement must be discontinuous across a pour strip.**

Any reinforcement extending from one slab into the other will act as a tension tie, restrain the relative movement of the two slabs, and most likely cause cracking. All rebar and post-tensioning must be lap spliced inside the width of the pour strip only after the tendons have been stressed.

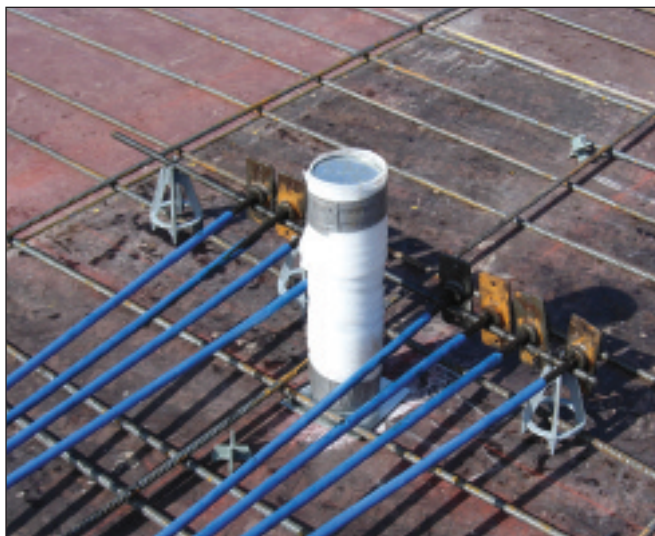
**Left: Slab penetrations too close to anchors can result in blowouts. Right: This horizontal blowout resulted from tendons that were curved in a very tight radius. On the left side of the photo, the imprint of the tendons prior to stressing can be seen approximately 12 inches away from their current location. During stressing, the tendons straightened and the concrete in the curve was unable to resist the localized lateral thrust.**

Whether in a small residential slab on grade or a 30-story hotel, each tendon will be loaded to roughly 33,000 pounds during stressing. This force is transferred to the concrete through the bearing of the ductile iron casting anchor against the concrete. If the concrete is not well vibrated near the anchors, if penetrations are located in front of the anchors, or if congested rebar prevents a uniform bearing surface, a concrete blowout is likely. The concrete will literally explode during tensioning as the anchors crush into the slab or beam, which then can cause the hydraulic jack to move suddenly and

violently. For this reason, only trained professionals should operate or be anywhere near the jack during stressing. If penetrations can't be relocated away from the anchors, steel pipes should be placed around the openings to resist the anchorage force.

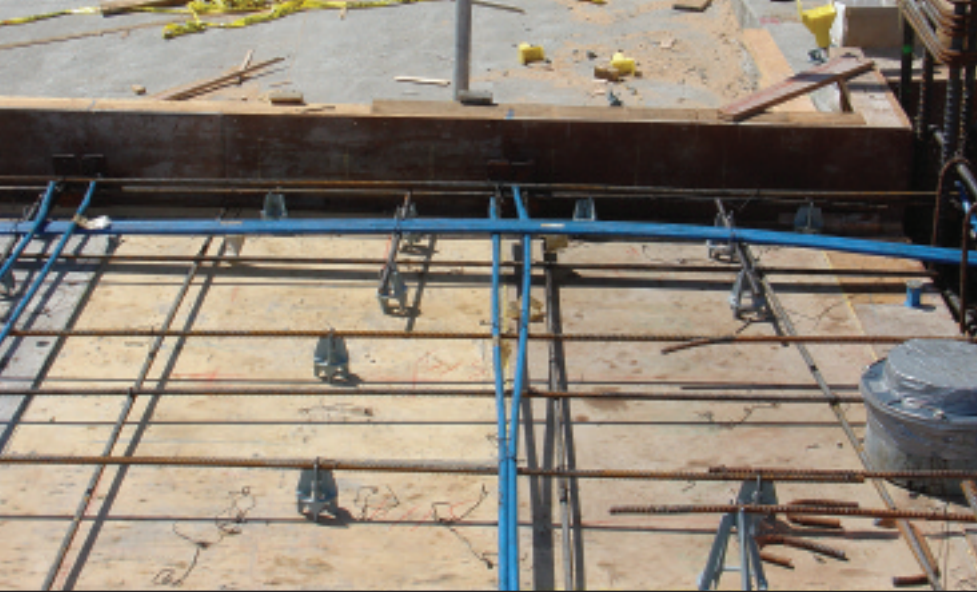
**These tendons will create a downward force that is nowhere near a band or a vertical support and that can cause cracking or a small blowout.**

Vertical draping of the strands is one of the main benefits of post-tensioning, but this needs to be done smoothly and gradually. Tendon discontinuities will produce localized point loads on the slab. Tendons draped in a reverse curve over other tendons will create a downward force. Instead of picking up the concrete, this reverse curvature will push

down into the lightly reinforced slab below, most likely causing cracks or a small blowout. Reverse curvatures are typically caused by the tendons being kicked off their chairs, wrong chairs being used, or the strand being tied off to a piece of rebar that has been moved after the tendon was secured.

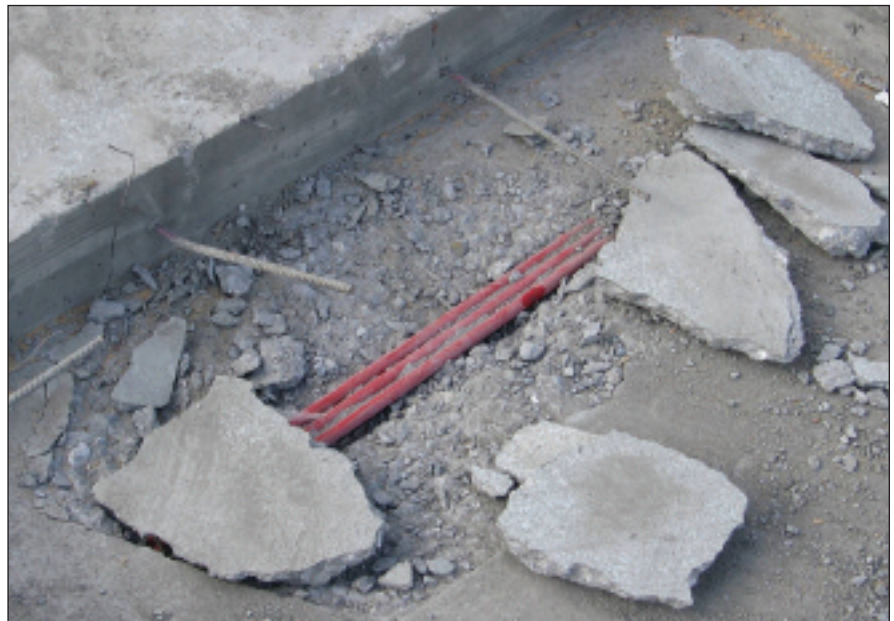
**This small blowout is a result of a localized low point in the tendons between two higher points. Note the gap beneath the tendons and the slab, indicating how much the tendons lifted.**
